# Snowplow issue

## Damaged fixture

Asset: +RW Y3.INT.WD=TCL009  
Asset Area: TCL (RW Y3)  
Asset Type: bGG\_i

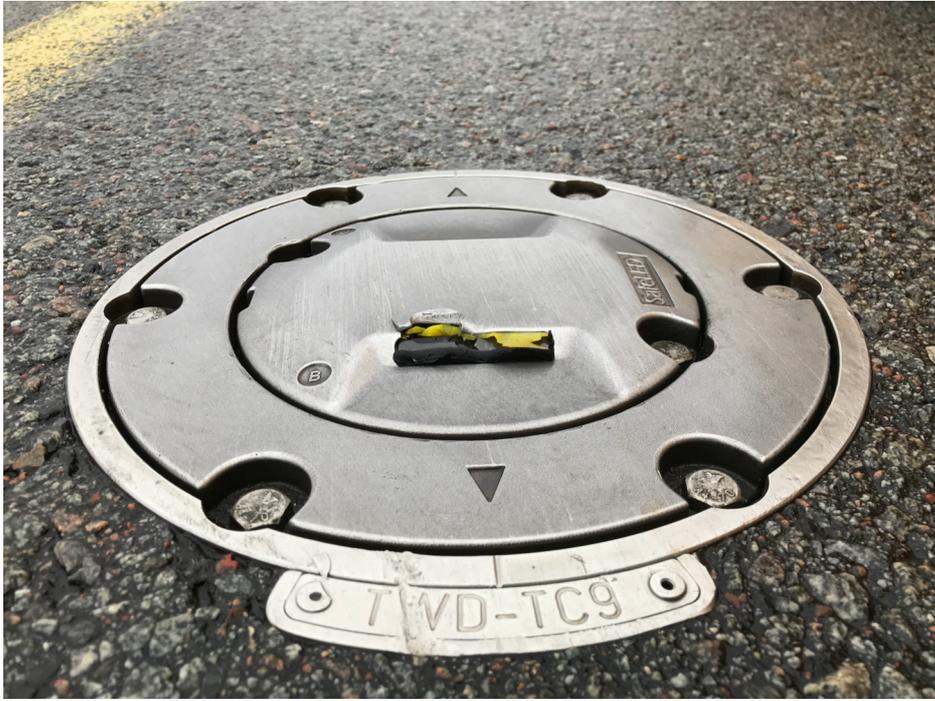
This is due to snowplow ; need for a snowplow ring
